GEOTECHNICAL RECONNAISSANCE OF THE 2010 DARFIELD (NEW ZEALAND) EARTHQUAKE

Version 1: 10 November 2010

EDITORS

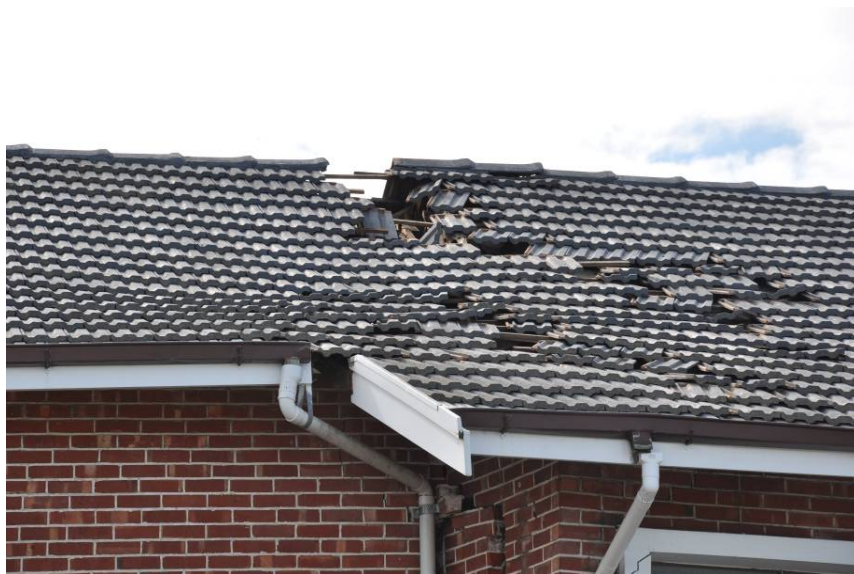
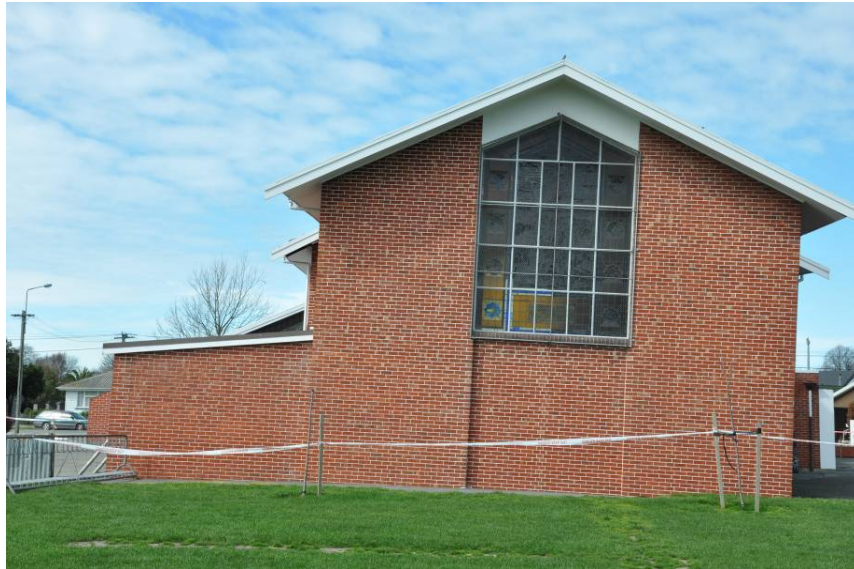
Figure 5.32. St. Paul's church in Dallington area - view looking north (a) far view of separated west end of building and (b) close-up view of structural separation (1400 hrs on September 2010)

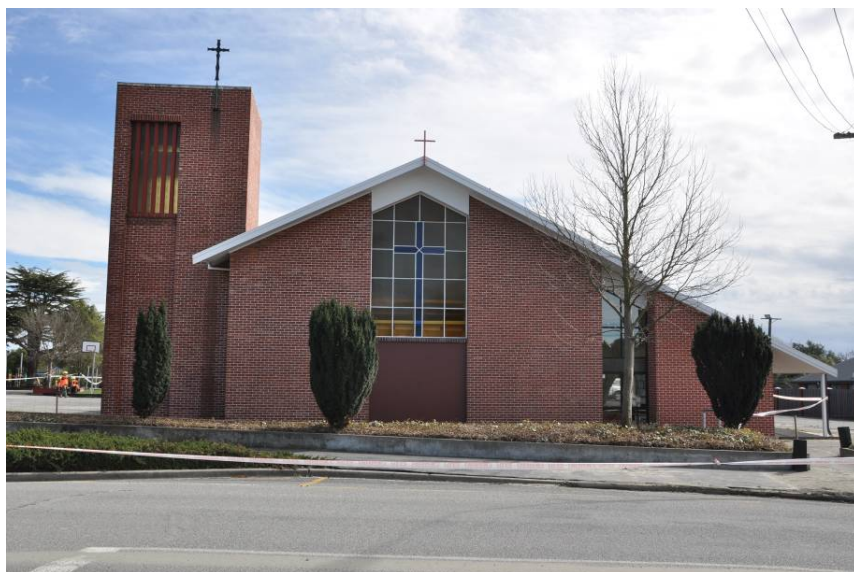
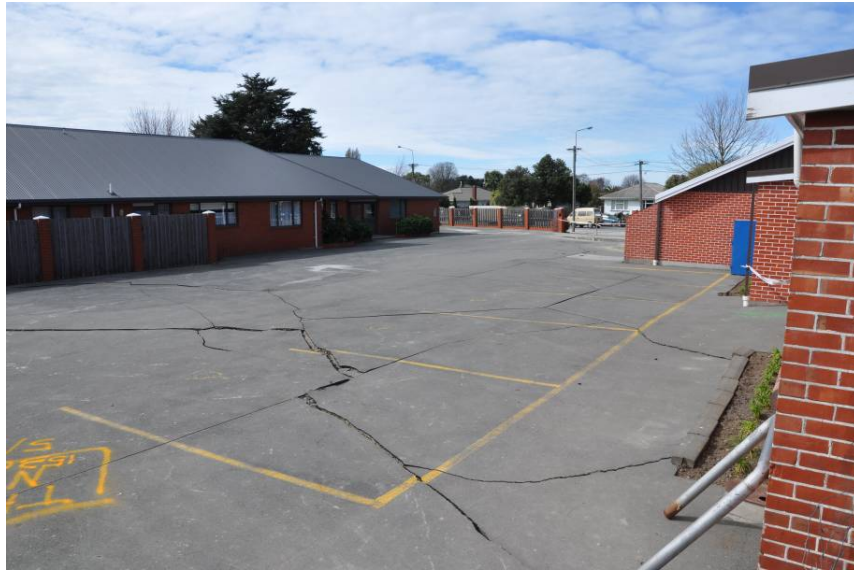
axis (running approximately east-west) along the building. The north and south (long axis ends) of the building articulate approximately 25% glass windows. Similarly the East entry facing Gayhurst Road presents stained glass features surrounded by brick walls (Figure 5.33b). The foundation was not accessible at the time of the NZ-GEER team’s visit.

Figure 5.33. St. Paul's church in Dallington area: (a) view looking east at the west end and (b) view looking west at the east end (1400 hrs on 12 September 2010)

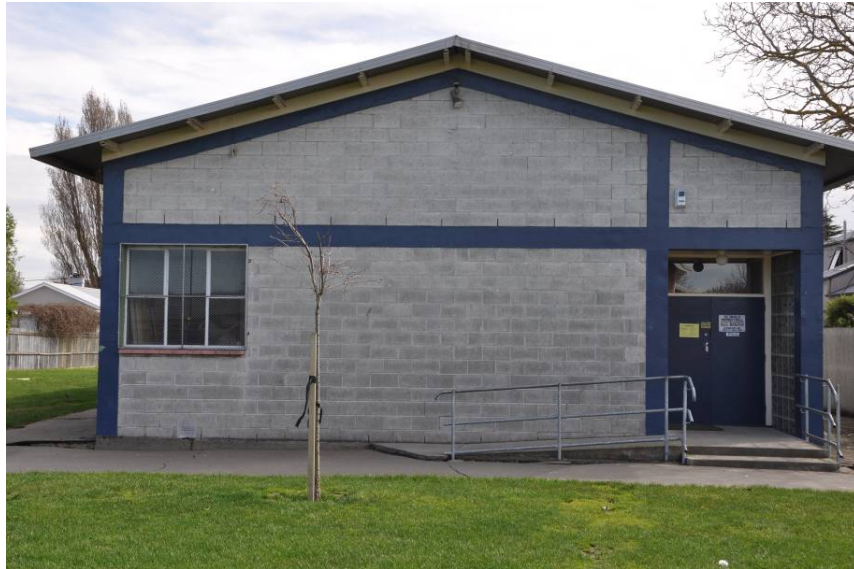
Surrounding St. Paul’s church is an Integrated State school affiliated with the church (buildings denoted B1-B8 in Figure 5.28). Building B1 (Figure 5.34) and B6 (Figure 5.36) are constructed of running bond brick perimeter walls with light metal roofs, whereas buildings B4, B5, and B7 incorporate light wood framing along their longitudinal axes and brick along their transverse axes (e.g. Figure 5.37). Building B2 is constructed of concrete masonry block units (Figure 5.35). All structures within the school appeared to be supported on elevated stem wall footings with interior wood joists, with the exception of B2, which appeared to be at grade with a slab on ground. Buildings B1-B8 are all single storey with wall heights ranging from 7-8m. Stiff brick and CMU buildings within this school complex suffered shear cracking and in some cases significant separation of brick-mortar joints (e.g. Figures 5.35b and 5.36b). Likewise mixed construction structures, such as building B7 suffered damage due to relative movement between contrasting materials (Figure 5.37b). Flexible wood buildings suffered little observable structural damage with the exception of hairline cracks in stucco aligned with ground movement features.

Figure 5.34 St. Paul's church and surrounding school - Building B1 (on left) and St. Paul's church (on right). (1345 hrs on 12 September 2010)

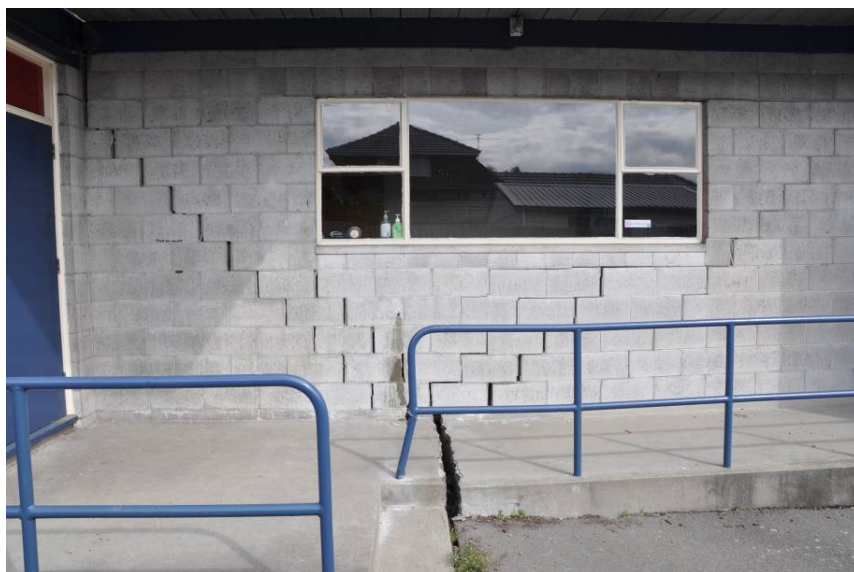
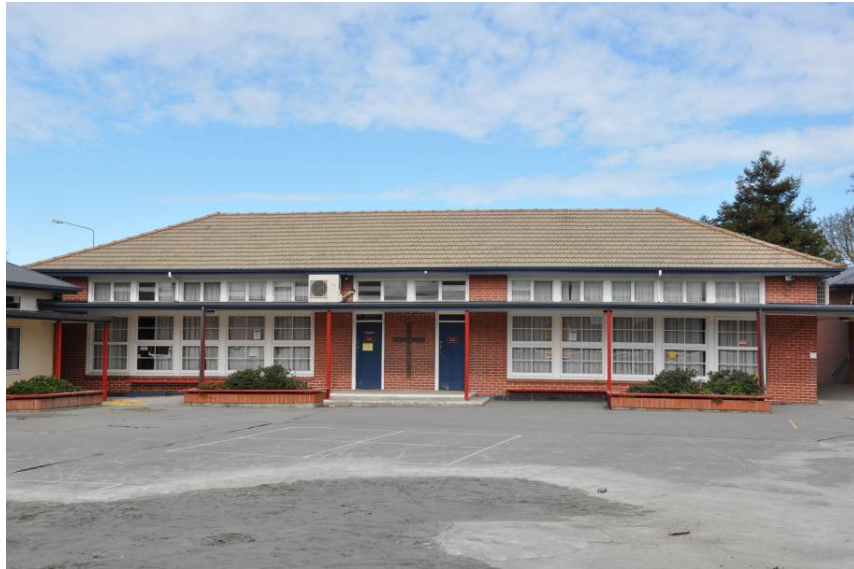
Figure 5.35 St. Paul's church and surrounding school - Building B2: (a) view looking west and (b) view from north side of building, looking south. (1300 hrs on 12 September 2010)

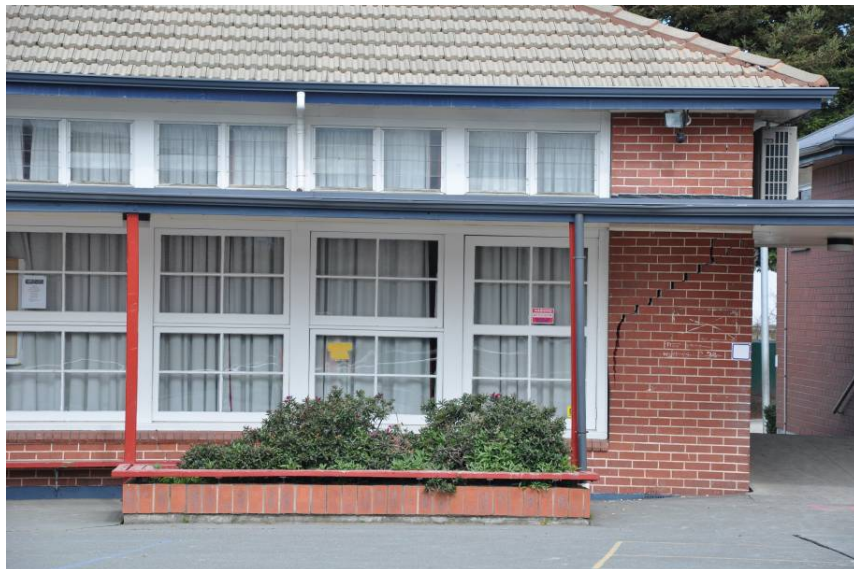
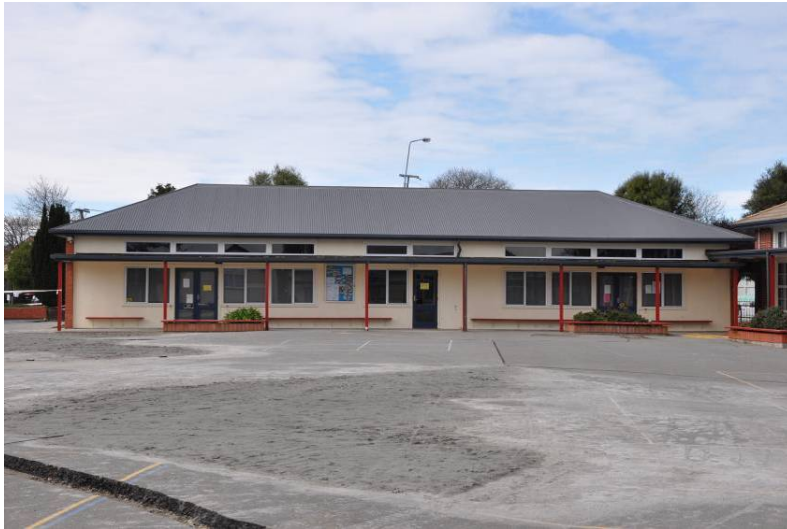
Figure 5.36 St. Paul's church and surrounding school - Building B6 view looking south: (a) overall view of building and (b) West end of building. (1300 hrs on 12 September 2010)

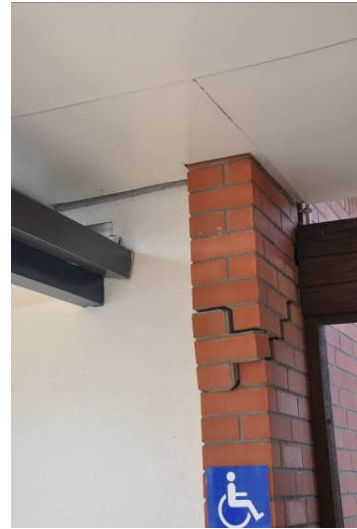
Figure 5.37 St. Paul's church and surrounding school - Building B7: (a) view looking east and (b) view of south-west corner of building articulating column damage at wood-brick interface. (1400 hrs on 12 September 2010)

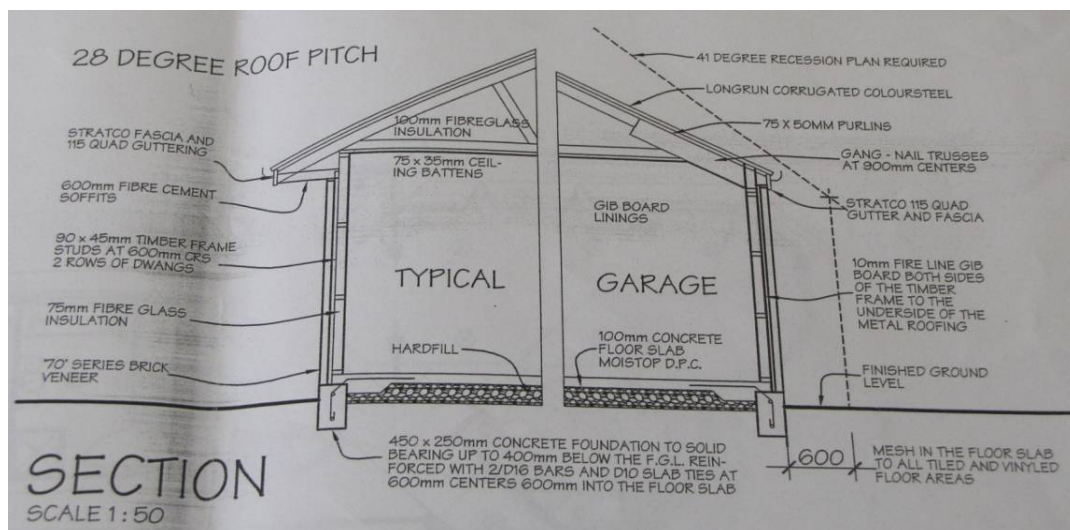
Foundation details taken during a visit to one home in Bexley are shown in Figure 5.40. The system set-out in Figure 5.40 is a perimeter beam with two D16 bars, D10 starter bars 600mm long at 600 mm centres around the edges. The cavity inside the perimeter beam is filled with coarse gravel, covered with dampcourse, and then topped with a 100mm thick concrete slab, which, apart from the starter bars, is mostly unreinforced. The drawing in Figure 5.40 specifies mesh reinforcing in areas that are to be tiled or covered in vinyl. Nonetheless, reinforcing was not observed to cross any fissure as noted in the drawing.

Figure 5.40. Concrete slab-on-ground details for the Bexley houses.

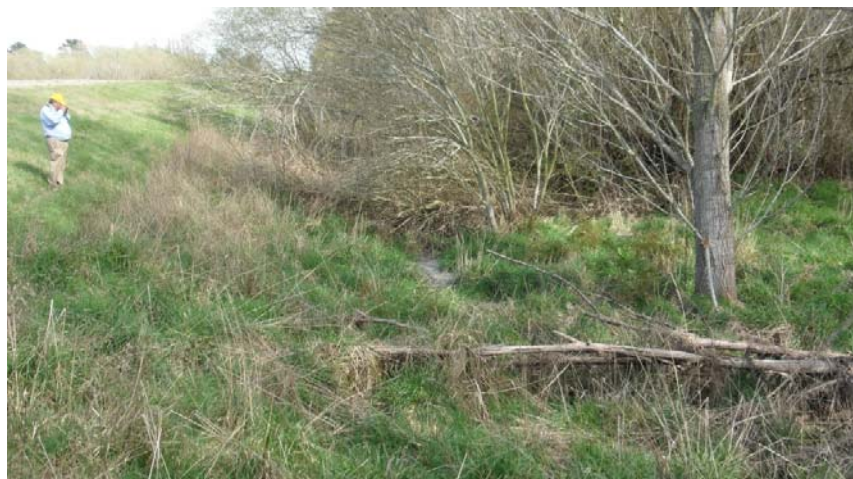
Figures 6.4-6.9 are photographs of the stopbanks for the Waimakariri River along Coutts Island Rd. Numerous sand boils were found along the base of the stopbank for an ~0.5 km stretch (Figures 6.4-6.6), on both the river and land sides. By the time of the team's damage survey on 11 September 2010, the top of the stopbank along this stretch had already been regraded (Figure 6.7), likely to fill in longitudinal cracks that formed along the crest of the stopbank. Figure 6.8 is of a ~2-cm wide longitudinal crack in the crest of the stopbank, located just outside of the ~0.5 km stretch where the crest road had been regraded. It is assumed that the longitudinal cracks in the stretch of the stopbank where the crest road had been regraded were more significant than that crack shown in Figure 6.8, thus warranting the regrading. The liquefaction along the base of the stopbank and longitudinal cracks in the crest abruptly stopped outside of the ~0.5 km stretch; this may be seen in Figure 6.9, where no damage to the stopbank could be found.

Figure 6.6 Photo 3: Liquefaction ejecta (centre of photo) along the base of the stopbank on Coutts Island Rd (riverside). (43.424093°S, 172.630468°E)

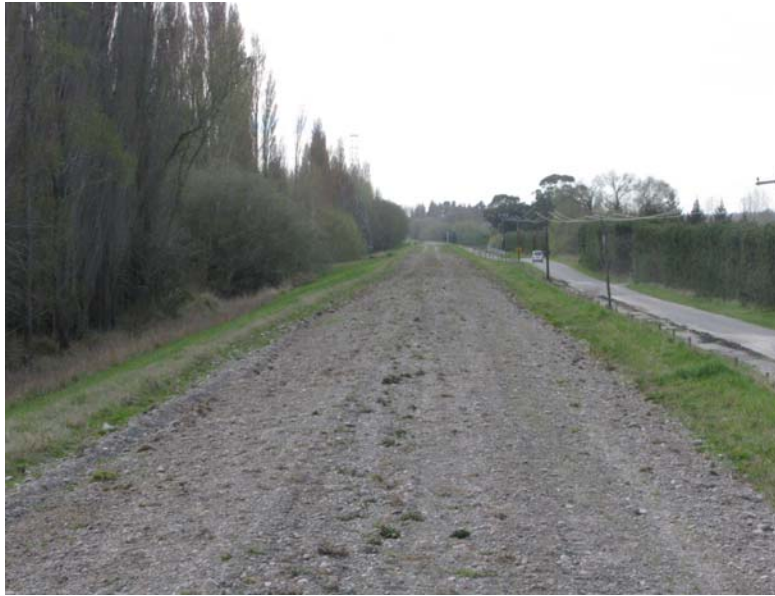
Figure 6.7 Photo 4: Road on top of stopbank that had recently been regraded, presumably after the earthquake to fill in longitudinal cracks formed during the earthquake. Liquefaction was observed along the base of both sides of the stopbank along this stretch. (43.423943°S, 172.631045°E)

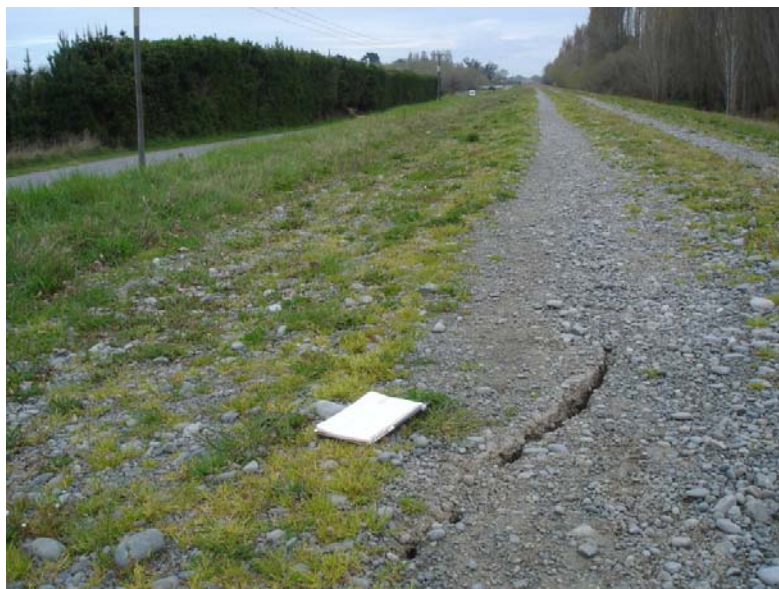
Figure 6.8 Photo 5: ~2-cm wide crack running lengthwise along the top of the stopbank on Coutts Island Rd. This crack was at the edge of the ~0.5 km stretch of the stopbank where significant liquefaction was observed. Photo taken looking southwest (43.423440°S, 172.632349°E)

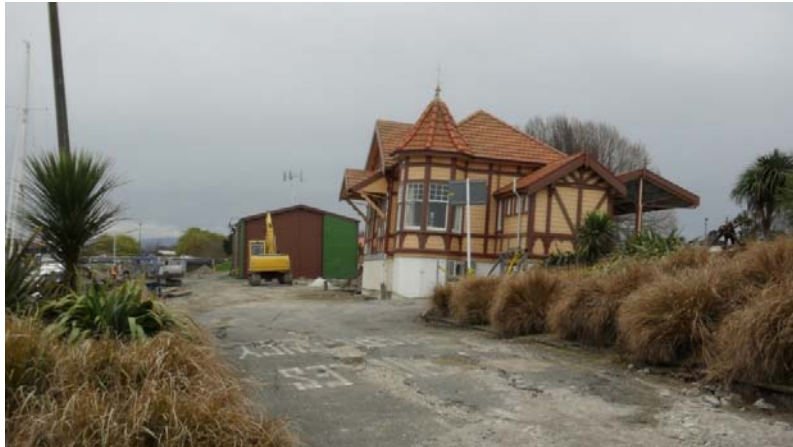
In downtown Kaiapoi adjacent to the river, the Visitors' Information Centre on the north side of the river sank and tilted as a result of liquefaction and lateral spreading (Figure 6.17). Ground cracks, as wide as 30 cm and as deep as 100 cm, were observed running parallel to the river near this structure. The two-storey Waimakariri-Ashley Coastguard building adjacent to the Visitor Centre also suffered the same effects. Just east of this building (~100 m), ground cracks, on the order of 100-cm wide and 185-cm deep were also observed along the gentle inboard (land-side) slope of the stopbank (Figure 6.18). Lateral spread cracks with massive ejecta were observed at the toe of the embankment (Figure 6.19). Also, a skate park that was located about midway up the gently sloping inboard side of the stopbank was severely damaged by lateral spreading (Figure 6.20). Settlement/slumping of the foot path on the crest of the stopbank on the order of 10-30 cm were also noted. Detailed maps of the largest lateral spread cracks will be provided in subsequent versions of this report.

Figure 6.17 Photo 15: Visitors Information Centre on the stopbank on the north side of the Kaiapoi River. The location of this photograph is denoted in Figure 6.2. (43.387384°S, 172.659743°E)

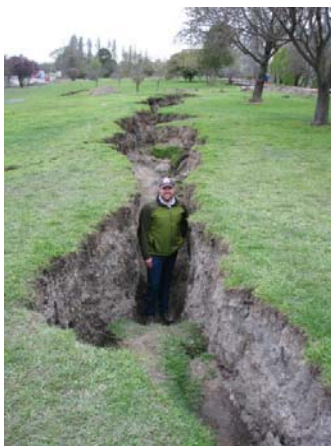
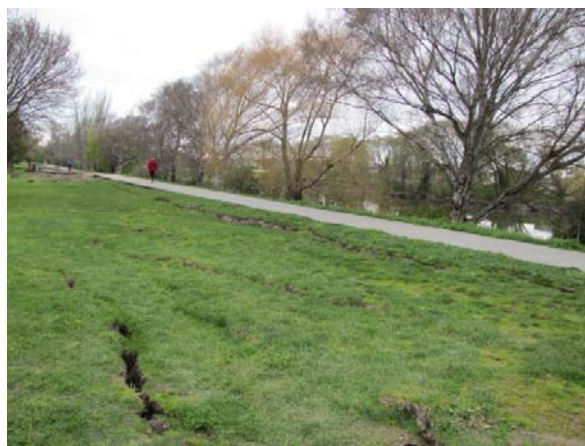
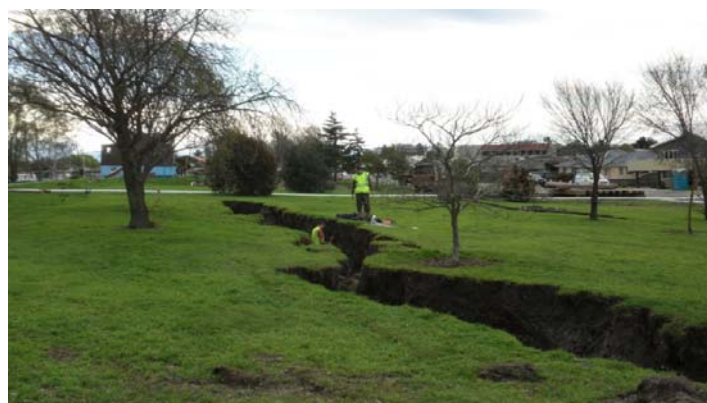
Figure 6.18 Photos 16-18: Lateral spread cracks along landside of the stopbank on the north side of the Kaiapoi River. The locations of these photographs are denoted in Figure 6.2. (43.384484°S, 172.660653°E)

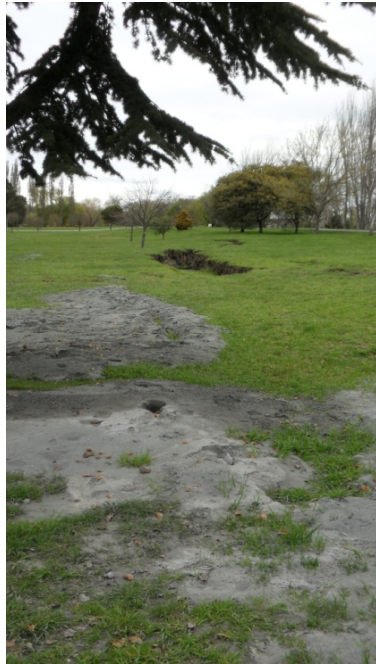
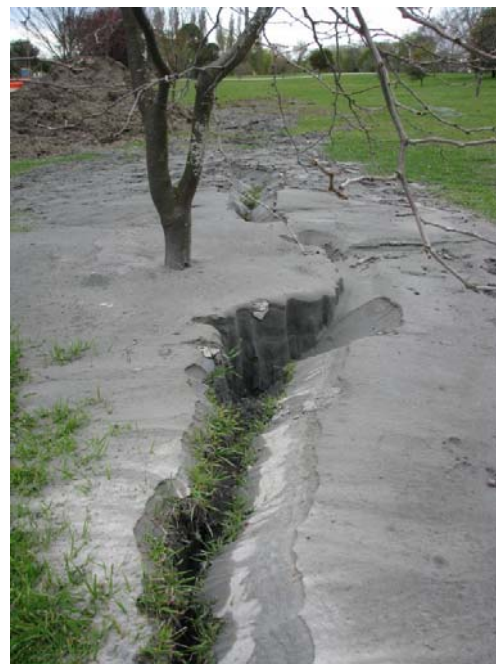
Two bore holes were made using a hand auger near the lateral spread cracks (43.384767°S, 172.661133°E and 43.384683°S, 172.661350°E). However, the profile largely consisted of random fill (gravels/cobbles and wood), making it difficult to advance the auger. One of the bore holes went down to a depth of ~5.5 m, yet a thick layer of soil matching the liquefaction ejecta material could not be found. However, thin (< 10 cm) alternating layers of loose saturated sand and very wet, very soft clay/plastic silt were encountered, particularly near the large lateral spread crack shown in Figure 6.18. This lateral spread crack had no trace of ejecta in and/or immediately near it. This crack was closer to the river than ones that were filled with ejecta at the toe of the stopbank ~30 m away (Figure 6.19).

Figure 6.19 Photos 19-20: Lateral spread cracks along landside of the stopbank on the north side of the Kaiapoi River. The locations of these photographs are denoted in Figure 6.2. (43.384633°S, 172.661231°E)

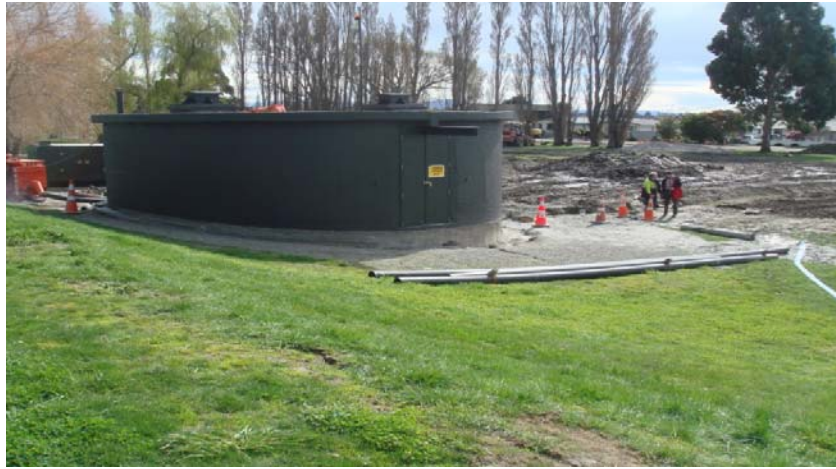
Further east along the Kaiapoi River (~400 m), the ground adjacent to a 6-m diameter structure (containing an underground tank and control equipment) settled by about 30 cm, resulting in damage to pipes attached to the tank (Figure 6.21). Additionally, aerial photographs of lateral spreading along the north bank of the Kaiapoi River going east from the town centre are shown in Figure 6.22.

Figure 6.21 Photo 22: The photograph numbers correspond to the locations denoted in Figure 6.2. (43.386918°S, 172.664412°E)

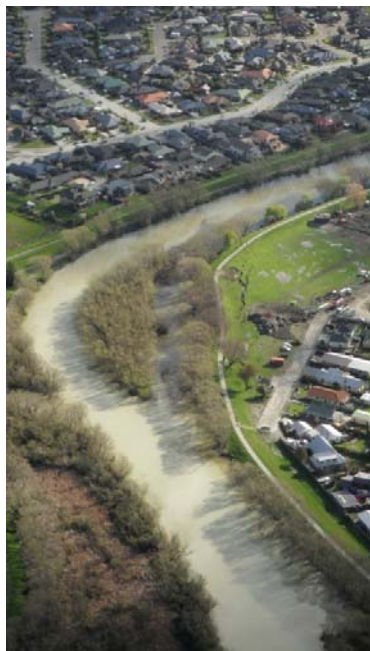
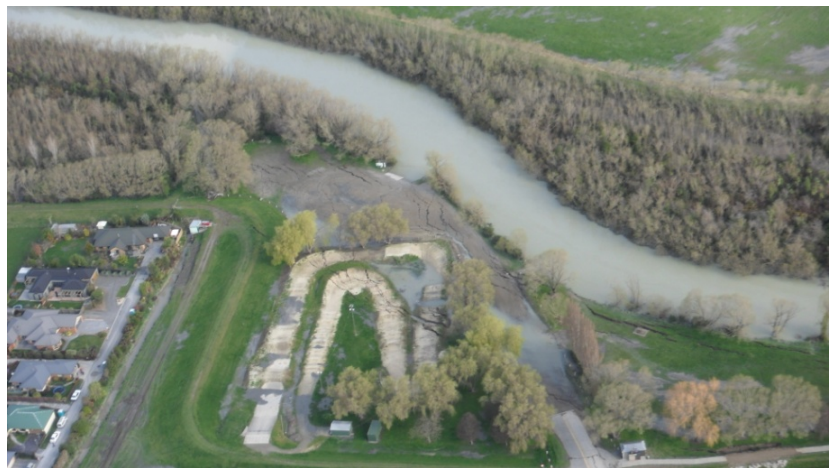
Figure 6.22 Photos 23-24: Aerial photographs of lateral spreading of stopbanks on the north bank of the Kaiapoi River. The locations of these photographs are denoted in Figure 6.2. (left: 43.387389°S, 172.666173°E; right: 43.386875°S, 172.672297°E)

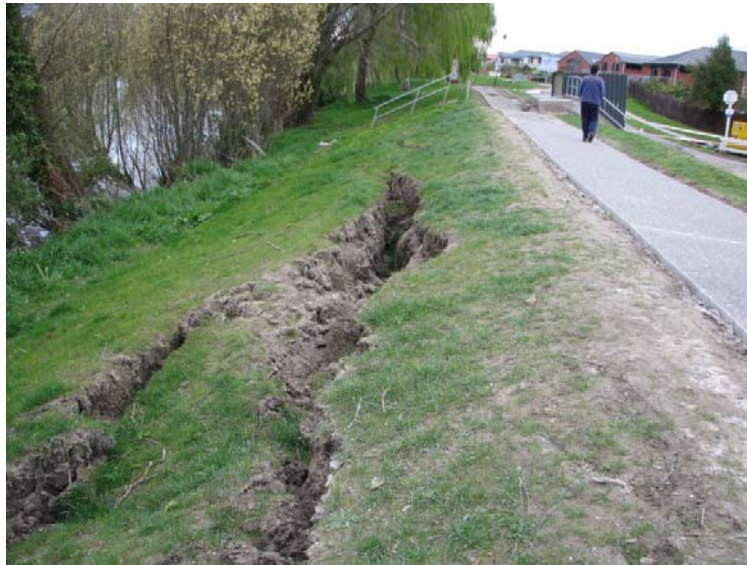
The stopbank along the south bank of the Kaiapoi River also experienced extensive lateral cracking, and the adjacent homes on Raven Quay experienced significant post-earthquake settlement. Figures 6.23-6.26 are photographs of the stopbank on the south bank of the river.

Figure 6.23 Photo 25: Lateral spread cracks along riverside stopbank on the south side of the Kaiapoi River. The location of this photograph is denoted in Figure 6.2. (43.385254°S, 172.660131°E)

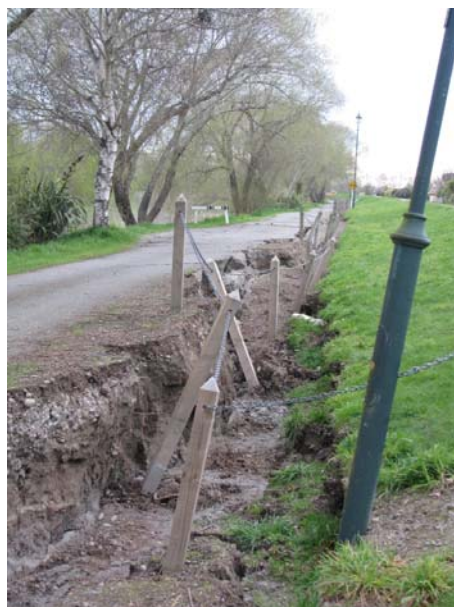
Figure 6.24 Photo 26: Lateral spread cracks along riverside stopbank on the south side of the Kaiapoi River. The location of this photograph is denoted in Figure 6.2. (43.385839°S, 172.660941°E)

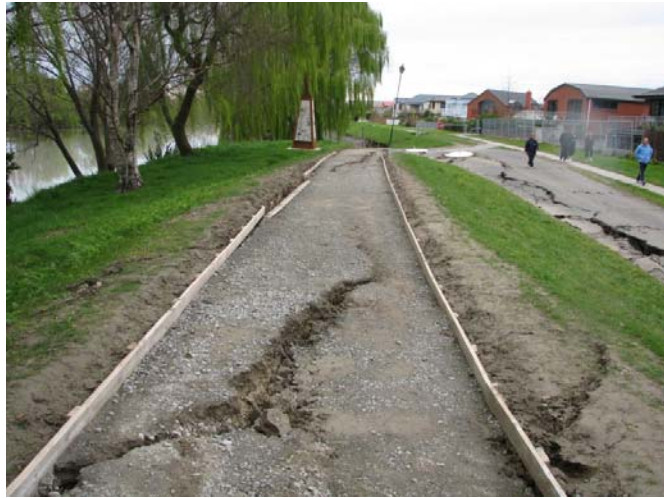
Figure 6.25 Photo 27: Lateral spread cracks along the top of the stopbank on the south side of the Kaiapoi River. The location of this photograph is denoted in Figure 6.2. (43.385693°S, 172.660688°E)

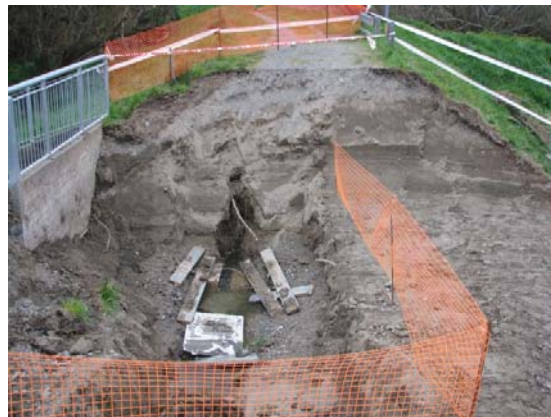
Figure 6.26 Photo 28: Failed drainage conduits running underneath the stopbank on the south side of the Kaiapoi River. The location of this photograph is denoted in Figure 6.2. (43.388679°S, 172.666203°E)

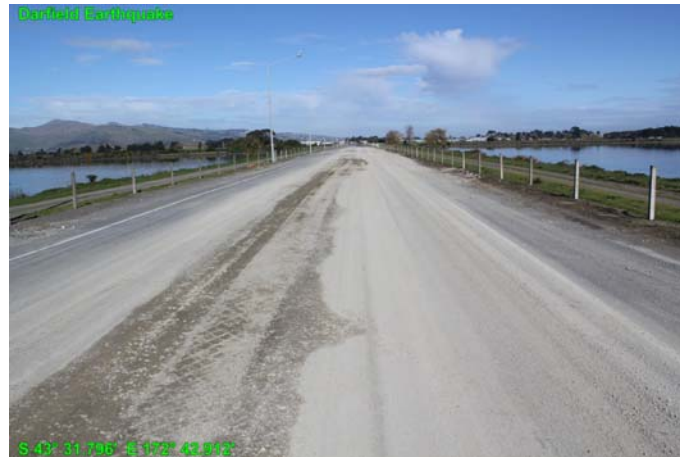
Dyers Road along State Highway 74 cuts through the oxidation ponds and connects the northern approaches to Christchurch with the port of Lyttelton to the south. Road pavements were cracked at the side of the oxidation ponds (between Ponds 2A and 3) and the road was impassable following the earthquake. According to the engineer interviewed at the site, a 50 cm wide crack had opened near the centreline of the road, although it was already filled with compacted dense graded aggregate during the site visit (Figure 6.30). Nevertheless, longitudinal cracks were still evident on the side of the road (Figure 6.31).

Figure 6.30 Repaired road that runs between Ponds 2 and 4. (43.529933°S, 172.715200°E)

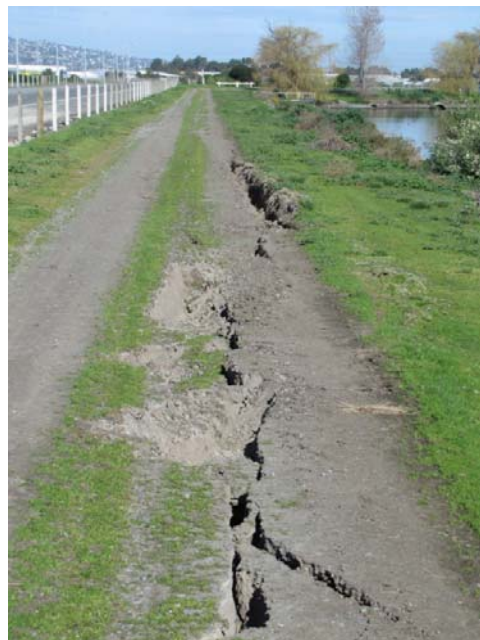
Figure 6.31 Lateral spread cracks running along the side and parallel to the road that runs between Ponds 2 and 4. (S43.531393°, 172.712473°E)

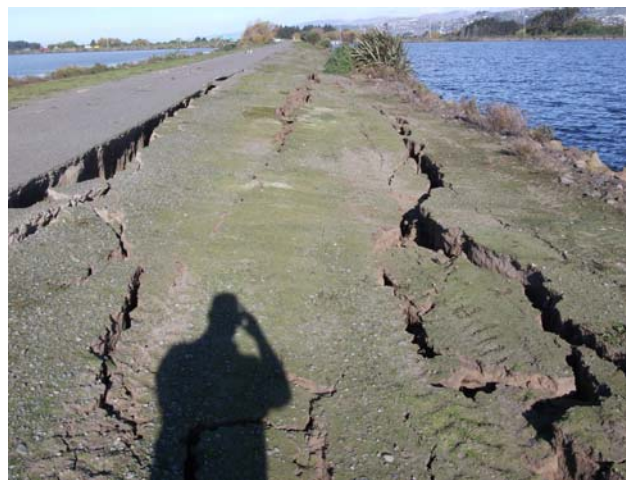
The middle third of the Pond 1/2A embankment sustained the most severe failure throughout the pond system over a length of around 450 m. At this location there are multiple deep longitudinal cracks along the embankment (Figure 6.32). The cracks were 150 cm deep and up to 70 cm wide at the top. Many of the cracks were interconnected and some were transverse to the embankment, running from Pond 1 to Pond 2A. There is a 122 cm diameter concrete pipeline beneath Pond 1 which can take flow from the treatment plant and bypass it directly to Pond 4. This pipeline "floated" over several hundreds of metres by up to 1.2 m in elevation, but typically less than 30 cm (Figure 6.33). During site inspections on Monday 6th and Tuesday 7th September 2010 there were no observations that the pipeline had "floated". Also examination of the Google GeoEye image taken hours after the earthquake showed no trace of this pipe. The pipe was firstly observed to have "floated" on the 9th September 2010 as the pond water level was being lowered as part of the emergency mitigation measures.

Figure 6.32 Lateral spread cracks running parallel to Dyers Road adjacent to Pond 2A (43.531393°S, 172.712473°E)

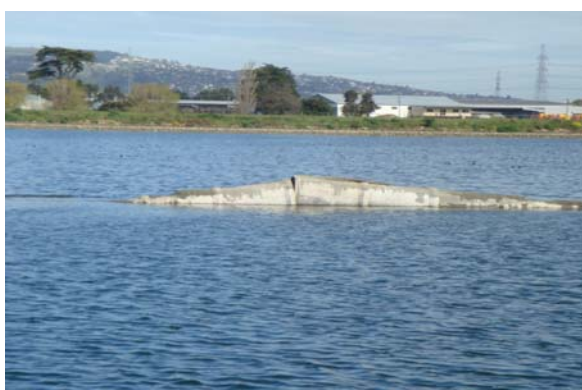
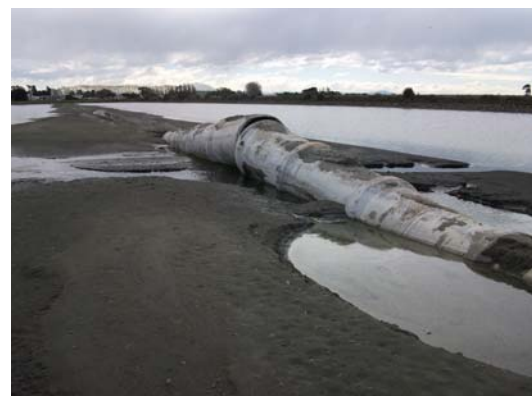
Figure 6.33 Buckled pipe protruding from Pond 1 during pond dewatering, and after pond level was lowered. Pipeline crown was at the pond invert prior to the earthquake. (43.530867°S, 172.705190°E)

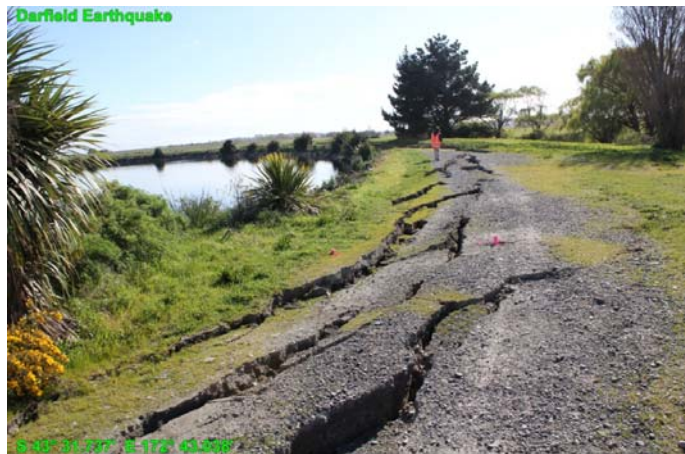
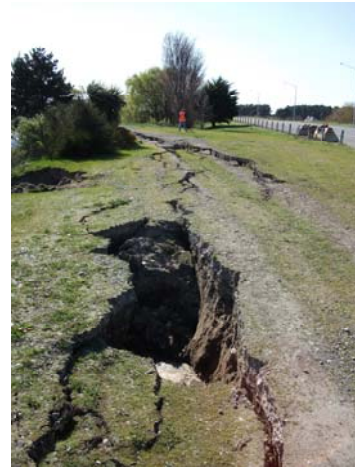
The distortion of the embankments noted above is indicative of bearing failure of the embankment as it has settled and spread in to the liquefied sub-soils, with large tension cracks forming through the fill used to form the embankments and pulling apart of concrete pipelines as the fill has spread. Site investigations undertaken indicate that the soils beneath the pond embankments are potentially liquefiable to depths of 10 m to 15 m.

Figure 6.34 Lateral spread cracks at the eastern end of Pond 2B. The sink hole in the foreground of the photo on the right formed over the top of two outlet pipelines. (43.52895°S, 172.717300°E)

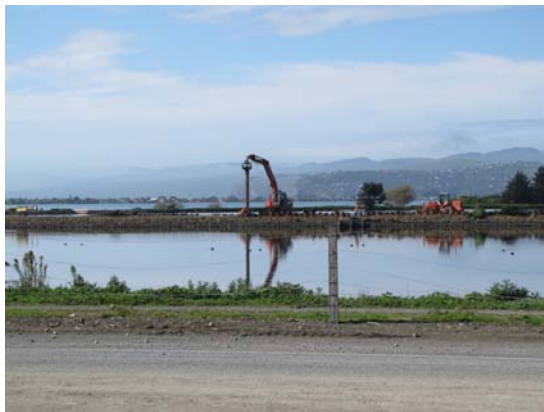
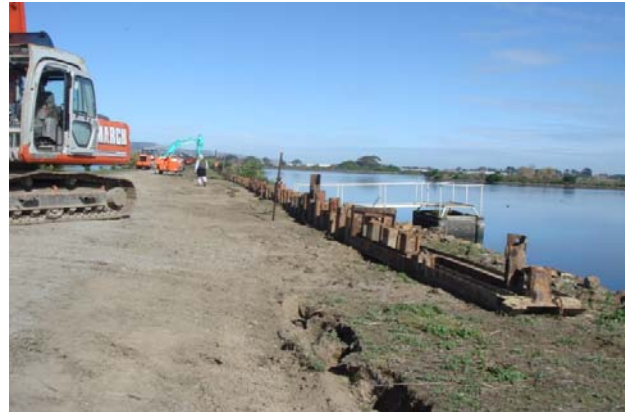
Figure 6.35 Sheetpiles being driven to stabilize the pond embankment to arrest further movement. (43.530563°S, 172.718349°E)

Because of the slumping of the pond banks, engineers decided to drop the pond water levels and reduce the hydraulic pressures on the embankments. At the time of the reconnaissance team visit, sheet piles were being driven into the Pond 3/6 embankment to stabilize it and arrest further movement (Figure 6.35). Furthermore, the pipelines beneath Dyers Road were being replaced.

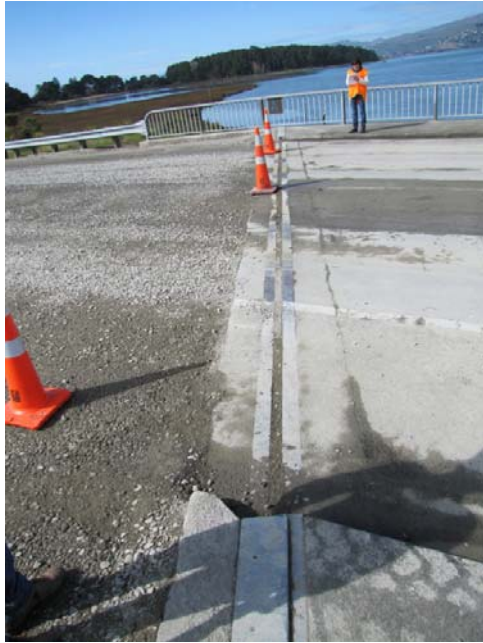
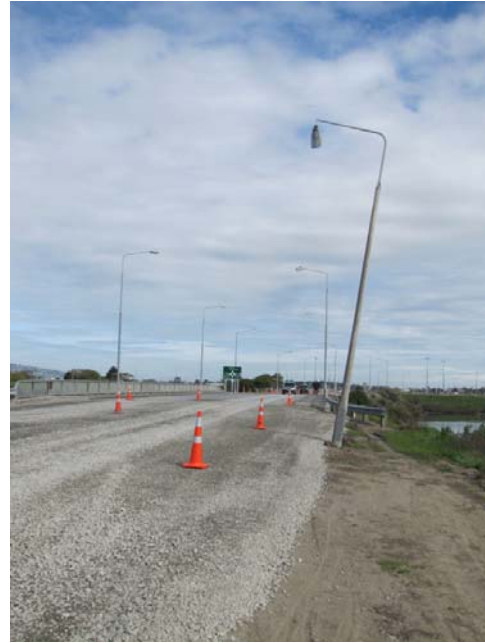
Figure 7.1 Repaired east approach to the Bridge Street Bridge

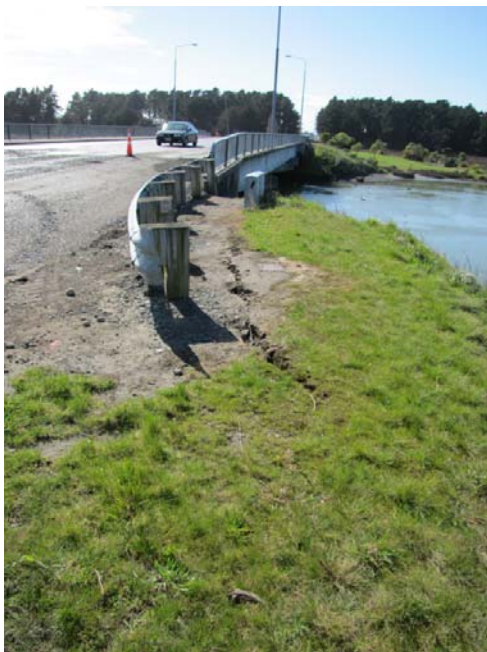
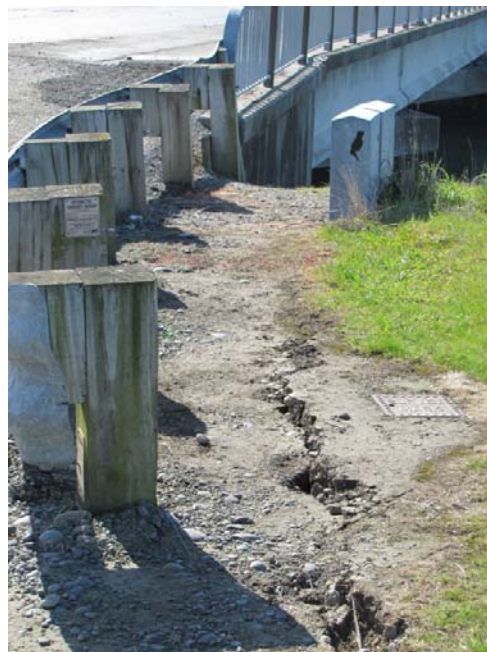
Figure 7.2 Cracking on margins of west approach embankment, Bridge Street Bridge

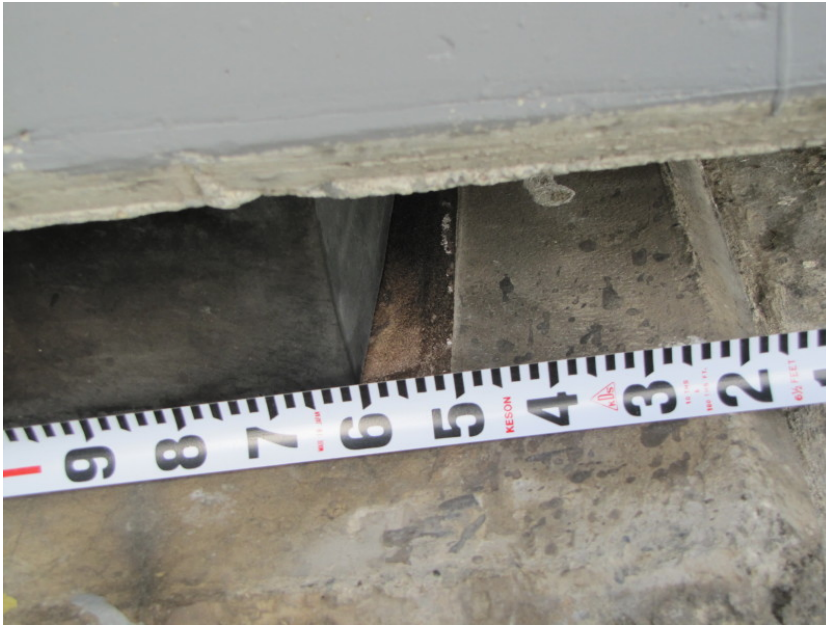
Figure 7.5 West abutment bearing pad displacement, Bridge Street Bridge (scale in Inches)

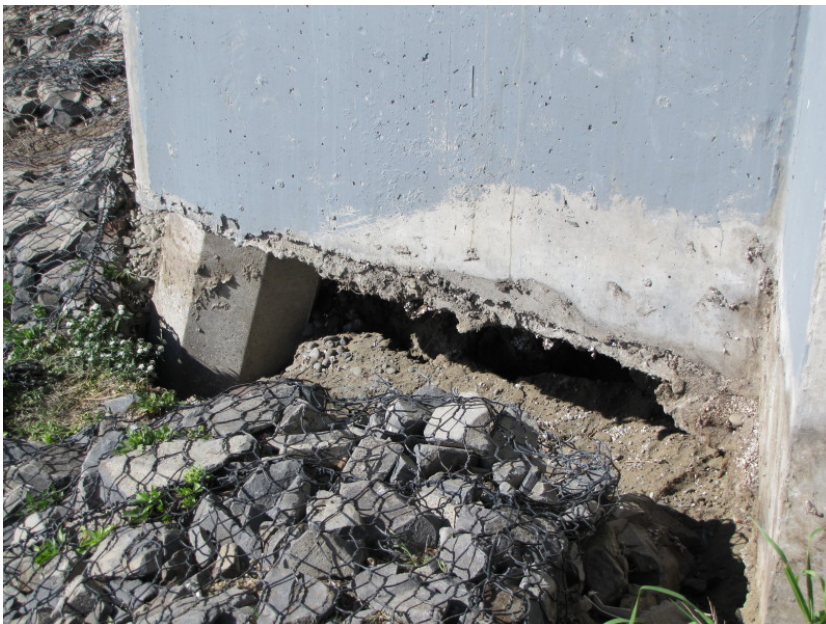
Figure 7.6 West abutment batter (angled) pile, Bridge Street Bridge

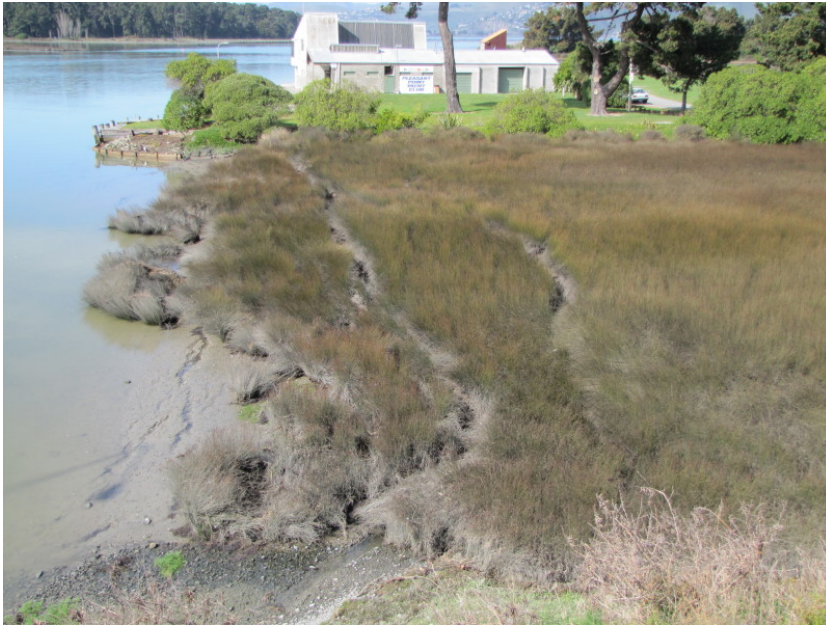
Figure 7.7 Lateral spreading on west bank, Bridge Street Bridge

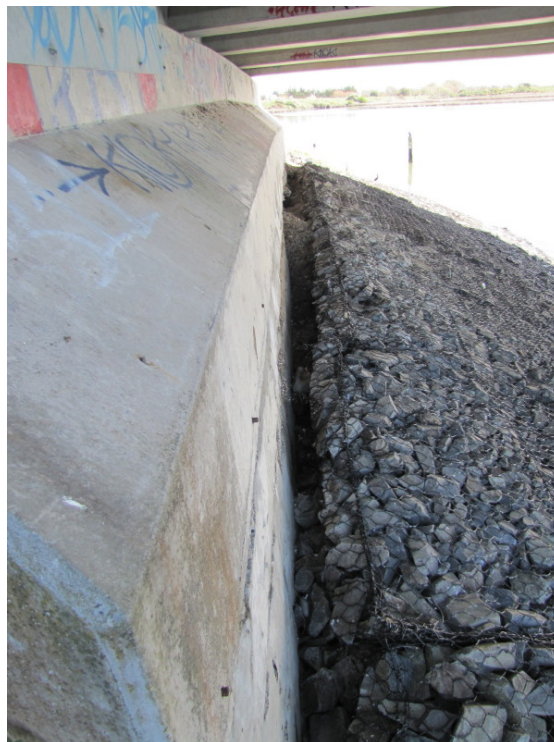
Figure 7.8 Gap between west abutment backwall and end embankment, Bridge Street Bridge

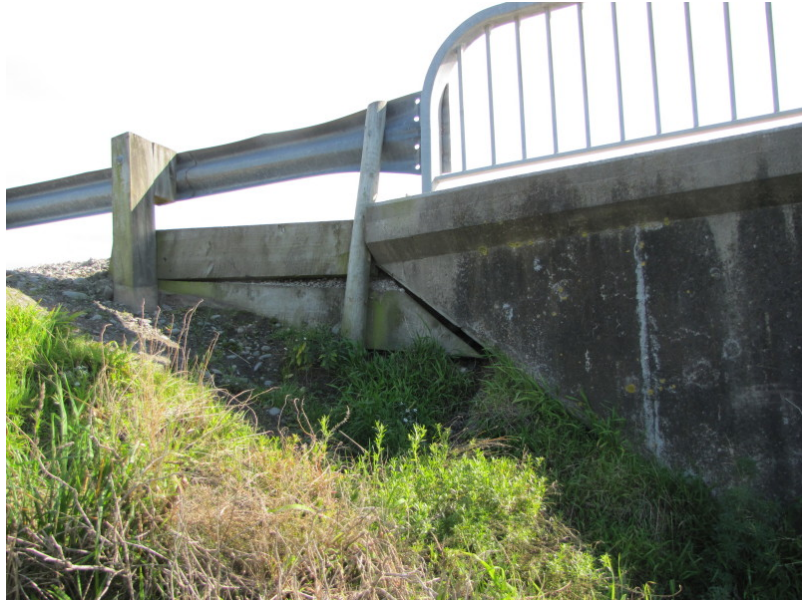
Figure 7.9 Back rotation of west abutment, Bridge Street Bridge

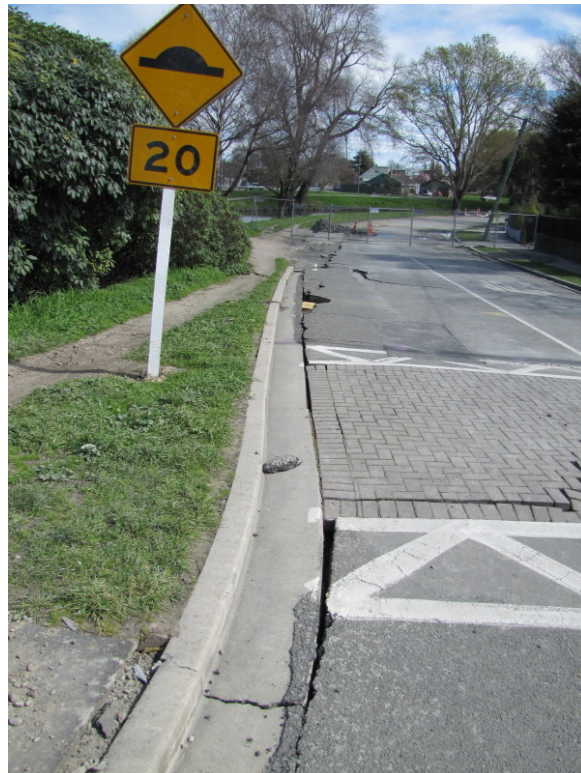
Figure 7.10 Cracking of roadway on west approach fill, Swanns Road Bridge

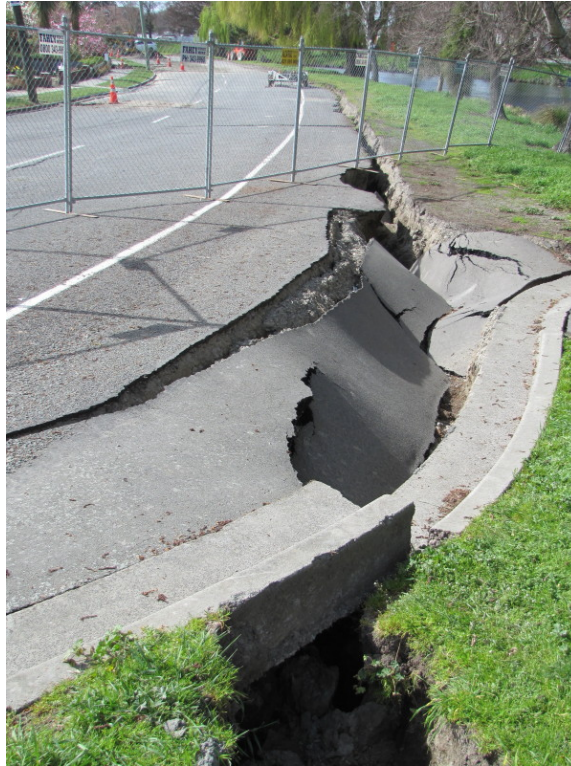
Figure 7.11 Lateral spreading on west approach fill, Swanns Road Bridge

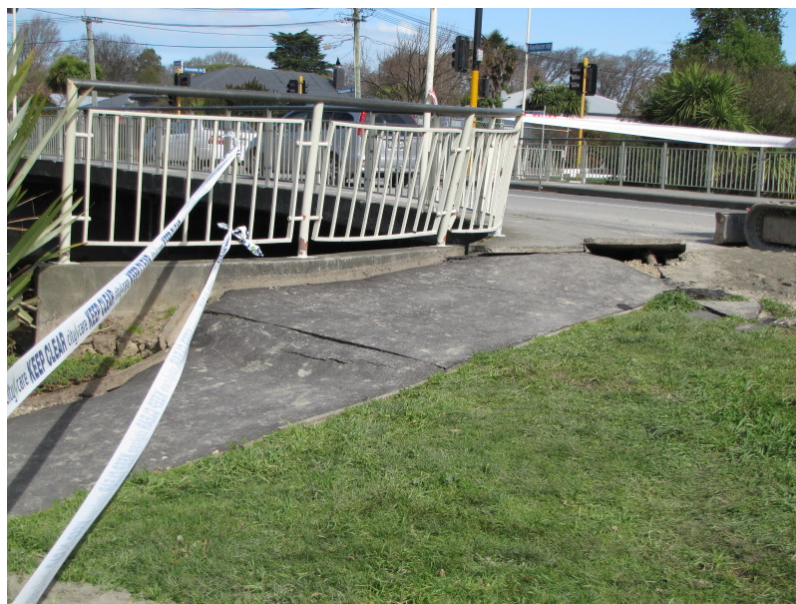
Figure 7.12 Incipient lateral spreading at west abutment, Swanns Road Bridge

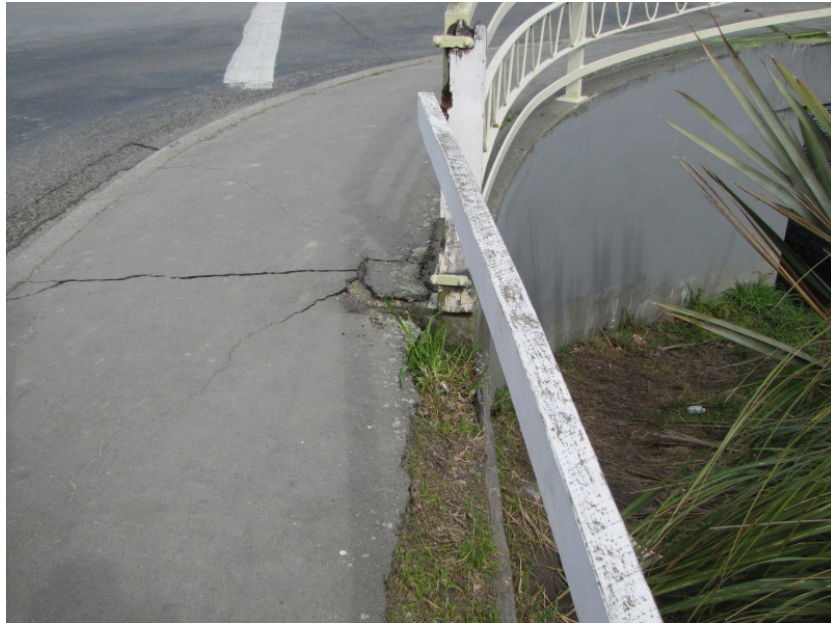
Figure 7.13 Incipient lateral spreading at north abutment, Gayhurst Road Bridge

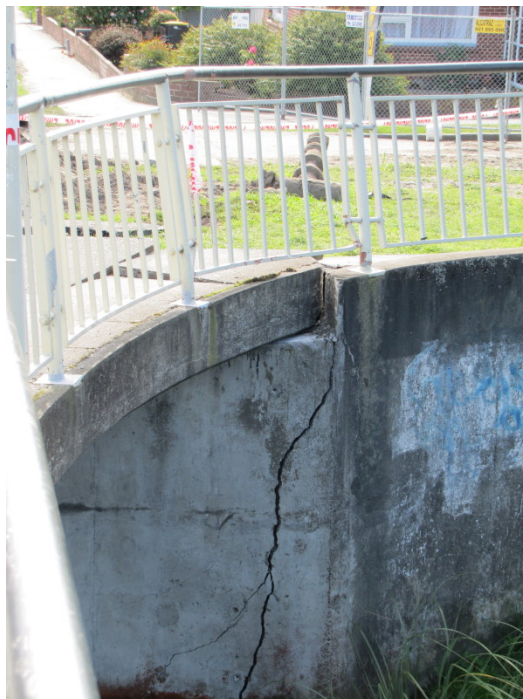
Figure 7.14 Cracking of north abutment, Swanns Road Bridge

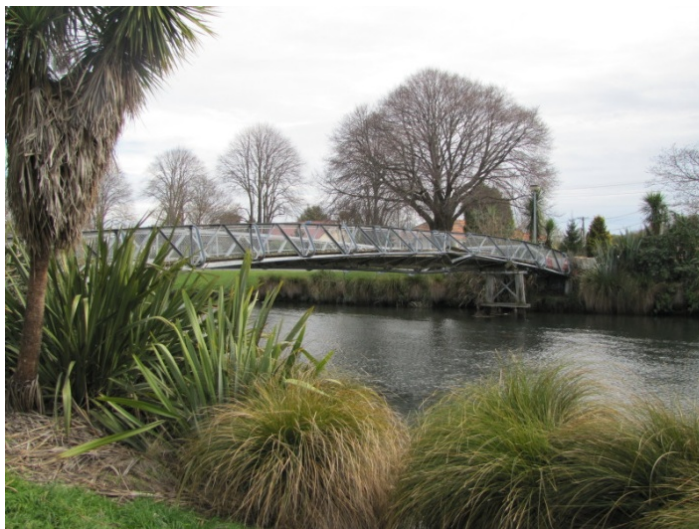
a) Buckled span

Figure 7.16 Footbridge on the Avon River near Medway Road
